## Fixing Houses with High Radon— A Canadian Demonstration

## Research Highlight

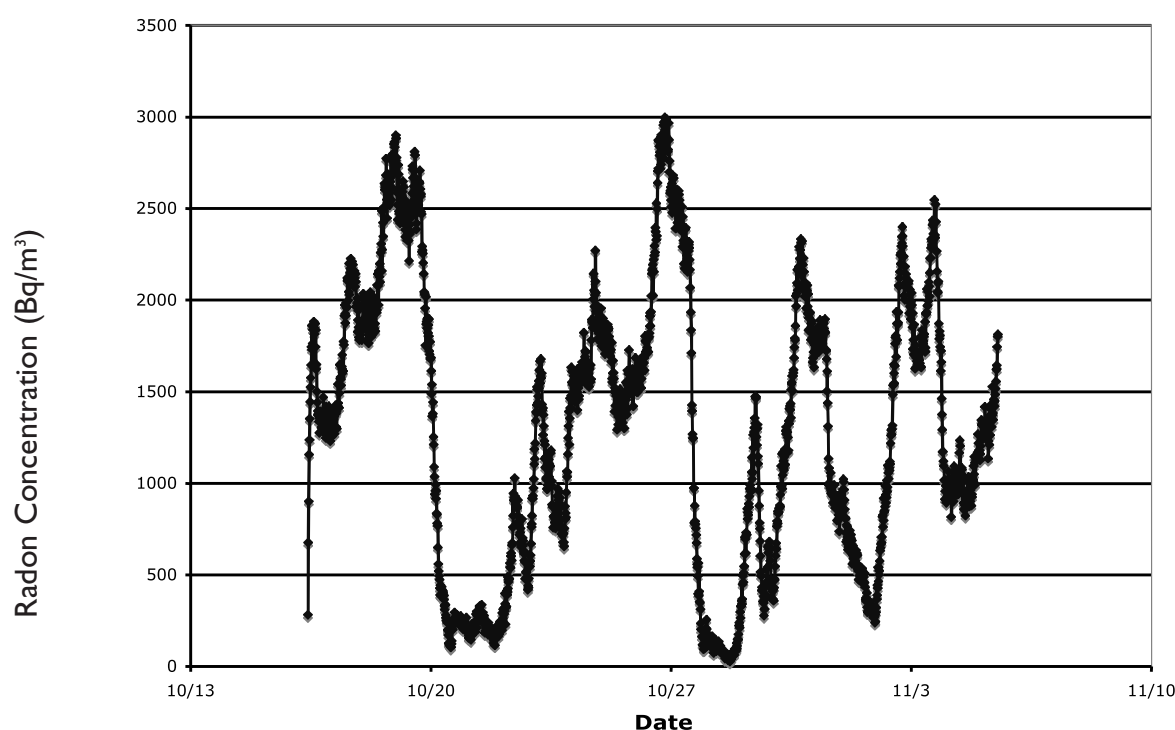
A homeowner in the community of Kanata in western Ottawa contacted CMHC and Health Canada for advice on high radon concentrations he had measured in his new house. Figure 1 shows almost a month of radon readings from his basement. Note that the concentration fluctuates due to house operation, climate factors, and so on. A short reading of two days duration could give a reading as low as 150 Bq/m<sup>3</sup> (for example, Oct. 28) or as high as 2,700 Bq/m<sup>3</sup> (Oct. 19). For that reason, *Radon: A Guide for Canadian Homeowners* recommends that houses be tested for at least one month.

Averaged over the test period, the homeowner's results were in the order of 1,400 Bq/m<sup>3</sup>, considerably in excess of either the new or old guideline. The basement had a poured concrete floor and walls, and was not remarkably different from neighbouring houses. It had a slab poured on polyethylene sheeting, which should reduce the radon entry rate.

**Figure 1** Continuous radon monitor trace, October–November, 2007

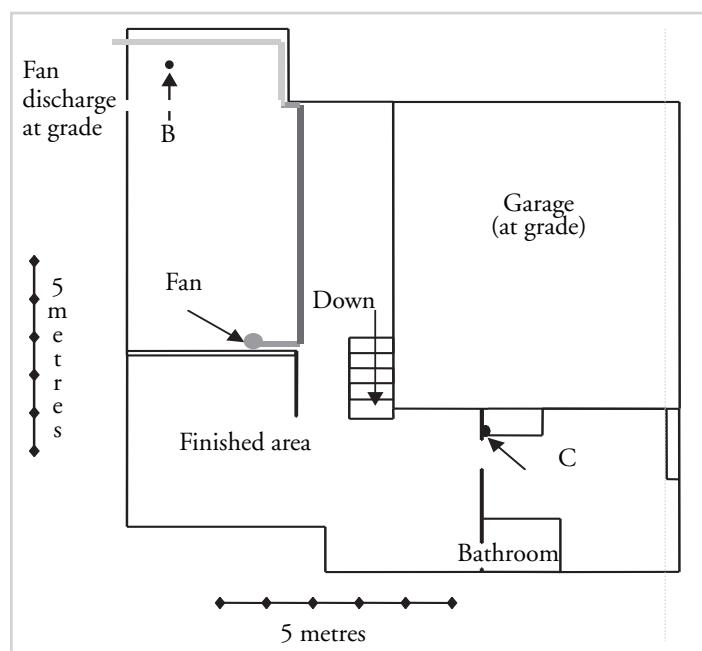
During the commissioning of the system, the fan flow was not quite high enough to make a consistent depressurization at the test holes B and C shown in Figure 2. This was cause for some concern, but it was decided to run the fan for a month and monitor its effectiveness before looking for a way to increase fan flow.

Figure 2 Installed fan and piping layout

The consultant drilled several small holes in the floor to measure whether all the air contained in the gravel layer under the slab could be depressurized by an exhaust fan connected through the slab at a single entry point. A ventilation contractor installed the fan and ducting to the consultant's recommendations, and the system was activated.

The exhaust fan discharged the sub-slab air at grade and not at roof level, as recommended by the United States Environmental Protection Agency (EPA). This was due to concerns regarding the possible condensation and ice build-up problems within vertical vents on the outside of houses in cold Canadian climates. The project team felt that, if re-ingestion of the exhausted radon through windows, doors or other envelop leakage points in the vicinity of the exhaust fan discharge point was a large factor, the post-mitigation test would show high levels of radon inside the house. The radon concentrations were measured for a month in the winter following installation of the system. Figure 2 shows the basement, the location of the measurement holes (B, C), and the fan and ducting system.

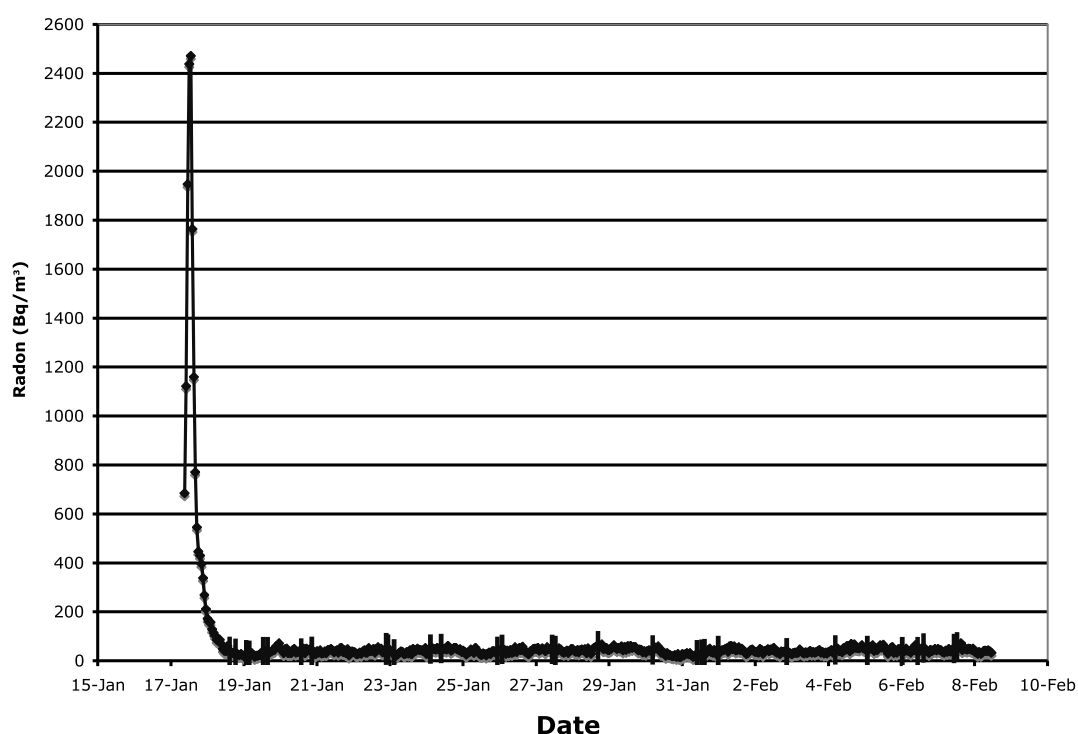
The system was remarkably effective (see Figure 3). Radon concentrations dropped from an average of 1,400 Bq/m<sup>3</sup> to about 40 Bq/m<sup>3</sup> for the month following, significantly below the HC 200 Bq/m<sup>3</sup> guideline. The homeowner was happy with the installation of the system and with the results. Re-ingestion of the exhausted radon was not a significant factor in this location during this period.

Figure 3 Continuous monitor trace during and after mitigation
