## Inspecting Wood Trusses

by Garet Denise, P.E.

Published July 2007

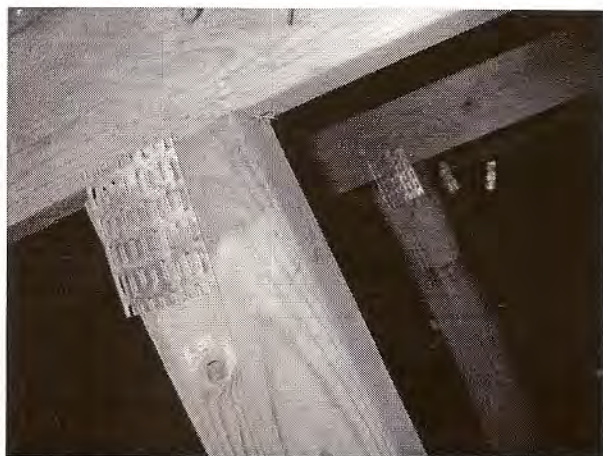
For simple joints, the plate should be centered, although this isn't always true for larger joints with multiple members coming together. Misaligned plates are not as strong as the designer intended (*see Figure 2*).

Figure 2: This metal connector plate was misaligned at the factory.

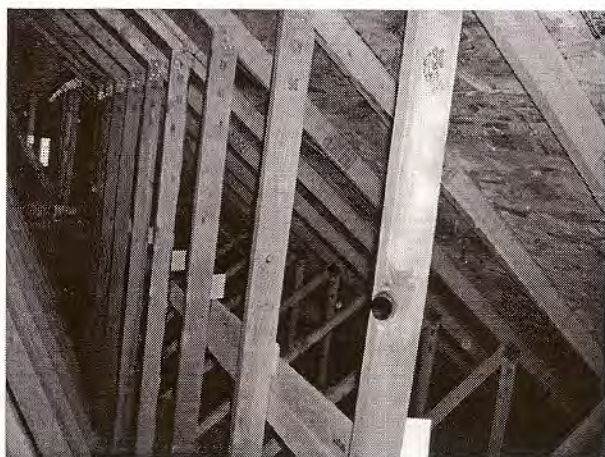
Since wood is a natural product, some knots are inevitable. But large knots weaken the member (*see Figure 3*), particularly if a metal connector plate is pressed into one. Acceptable knot size for metal connector plates should be listed in the manufacturer's evaluation report – which isn't likely to be available to you as a home inspector. If in doubt, refer the issue to a licensed structural engineer.

Figure 3: Knotholes weaken web members.

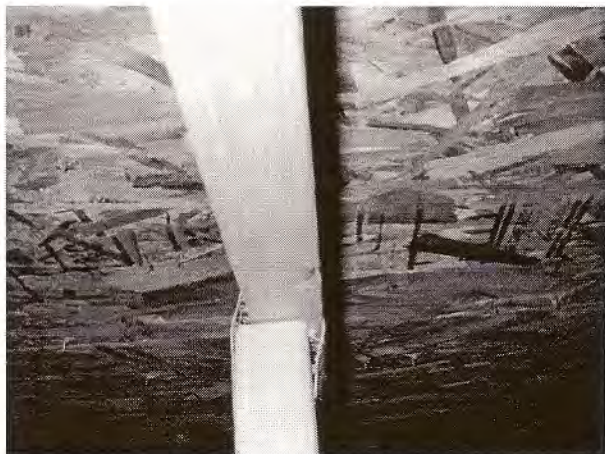
Damaged metal connector plates are one of the most common forms of damage. Obviously, a plate that's pulled completely out of the wood has no strength. But a plate that's pulled partway out no longer has full strength (see Figure 4). The Truss Plate Institute (TPI) publication QST-88, *Quality Standard For Metal Plate Connected Wood Trusses*, says that the gap under a plate should not exceed 10 percent of the tooth length or 1/16," whichever is greater. It also says that such a gap should not exceed 1/3 of the plate contact area on each member in the joint. Repair is not as simple as hammering the plate back in because the fingers on the plate are designed to be pressed one time into undisturbed wood.

Figure 4: Metal connector plates loose strength even when pulled only part way out.

The normal repair is to install a plywood or OSB gusset plate, nailed in place. These are usually much larger than the metal plate being replaced. The size and nailing pattern will be specified by the engineer. Sometimes an engineer will specify a metal replacement plate with nails.

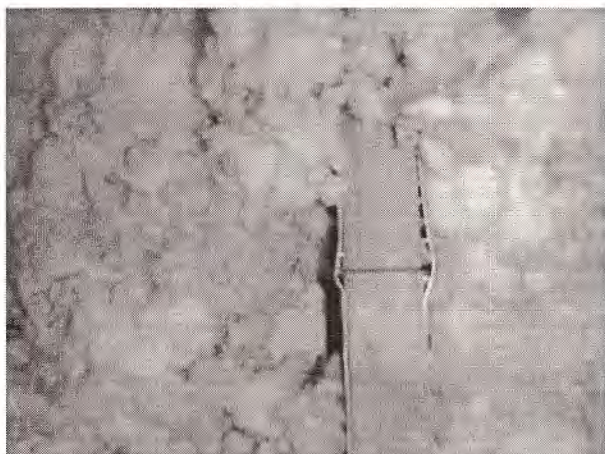
As a truss is bent sideways, the metal plates on the outside of the curve are stretched or pulled out (as described above), but the plates on the inside of the curve are compressed and can buckle. This damage is not as obvious (see Figure 5). If you find signs of damage in the accessible parts of the truss, you should also pull aside insulation to look for more damage to the lower chord.

Figure 5: Compression buckling of connector plate on truss that was bent during installation (left).

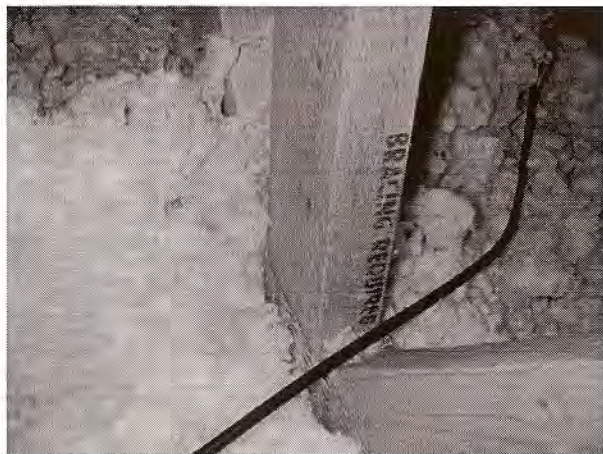
Figure 6: Ink stamp reads "BRACING REQUIRED".

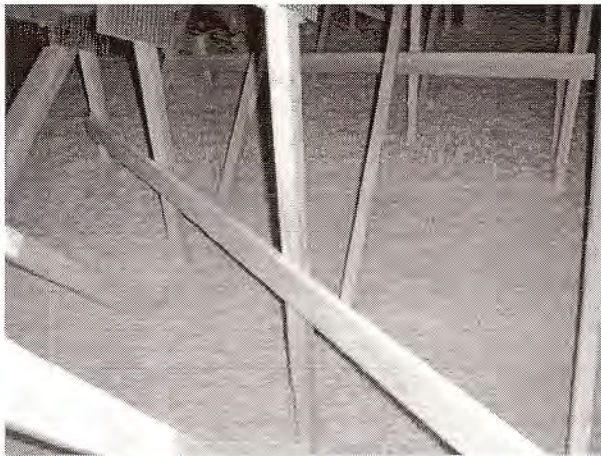
*Figure 8: CLR is not effective when applied to trusses that do not have similar web patterns.*

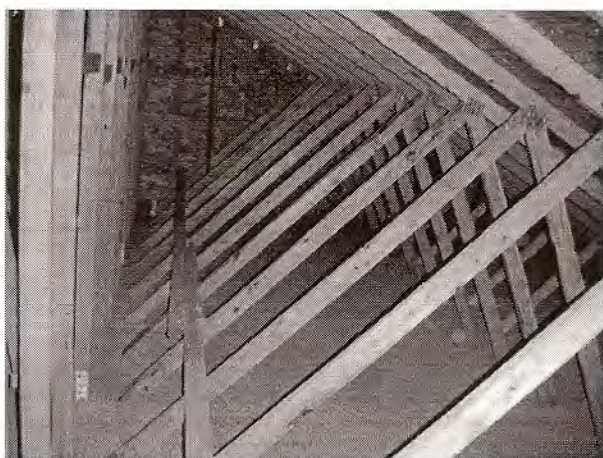
Figure 9: CLR should be roughly centered in span of web member.

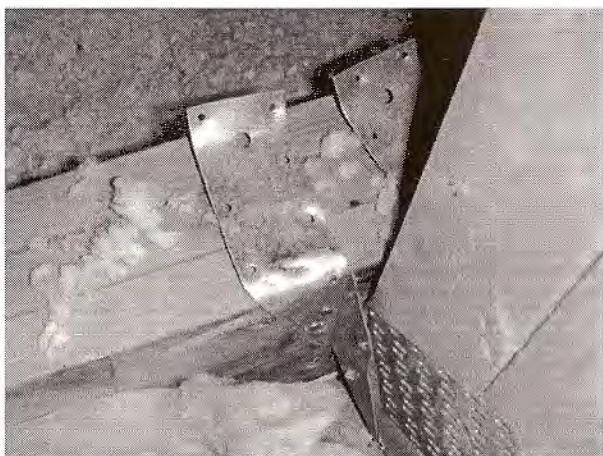
Trusses must be properly integrated with the rest of the building. A common problem is nails missing in metal hanger brackets supporting trusses. It's worth noting that several manufacturers make brackets that are intended to be bent over the top of the supporting framing, but all nail holes still need to be filled (*see Figure 10*). Structural connectors to hold trusses down to the wall structure should conform to IRC section 802.10.

Figure 10: All nail holes should be filled in metal hanger brackets.

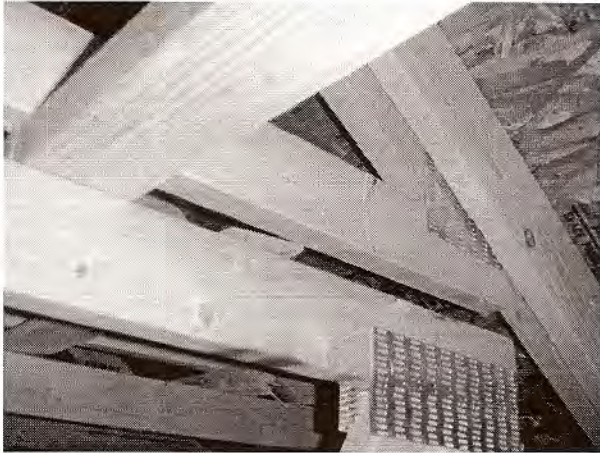
As we've made houses larger, sometimes the trusses are too tall to be shipped on the highway as a single unit. In these cases, the trusses are shipped in two sets, a lower set with a flat top chord and a smaller triangular set that rests on top of the lower trusses (commonly called piggyback trusses). Pay close attention where the upper trusses rest on the lower ones. Just like other trusses, piggyback trusses are designed with a specific bearing point, which is almost always at the end (*see Figure 11*). In high wind zones, the top section of

piggyback trusses may need to be strapped down to the lower set; toenailing may not be sufficient.

*Figure 11: These piggyback trusses are not supported at the bearing point.*

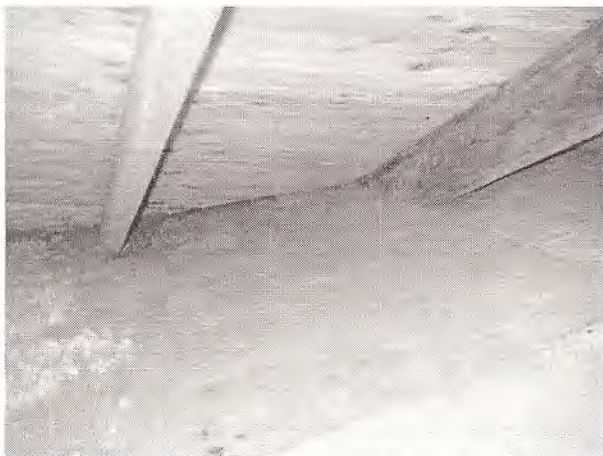
*Figure 12: These rafters bear only on-roof sheathing in between trusses.*

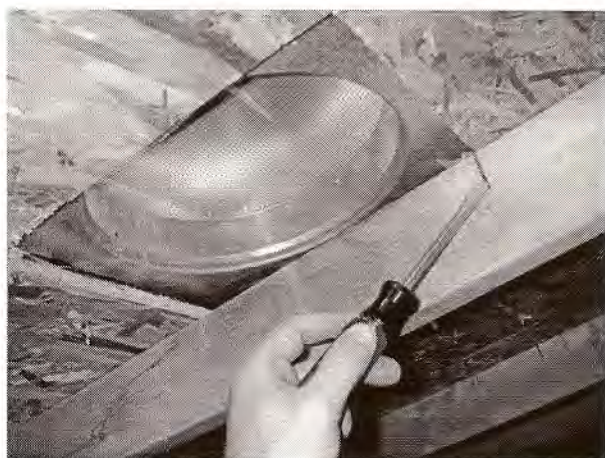
A major advantage of lumber as a building product is that it can easily be cut and nailed in the field, but this also makes it easy to make improper modifications. As previously discussed, any alterations to a truss must be backed up by engineering designs. Truss members commonly get cut during installation of whole-house fans, drop-down stairs, fireplace chimneys and recessed light fixtures. Truss members also get cut during installation of rooftop vents (see *Figure 13*) or when installing mechanical and plumbing systems.

*Figure 13: Truss members should not be altered in the field.*

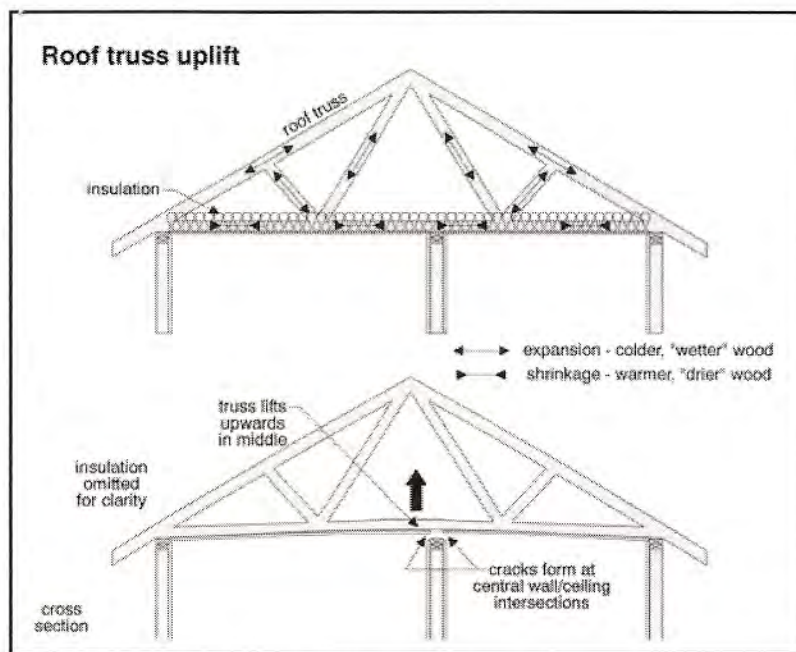
Because interior partition walls are typically not load bearing, a unique problem can develop where those walls meet the bottom of trusses, resulting in drywall cracks near the wall/ceiling joint. In areas where the relative humidity changes significantly from summer to winter, the truss lumber will expand and contract as its moisture content changes. As a result, the bottom chord of the truss will rise and fall seasonally as it bows up and flattens back out. This is called 'partition separation' or 'truss uplift' (see *Figure 14*). Other factors that can also cause partition separation include building settlement and deflection from snow or wind loads. You can read more about ways to avoid this problem in Partition Separation Prevention and Solutions, part of the Truss Technology in Building series published by The Wood Truss Council of America ([www.sbcindustry.com](http://www.sbcindustry.com)).

Figure 14: Partition separation (from Carson Dunlop Illustrated Home, #0438 in 1st edition).
