Cold Climate Radon Mitigation

INTRODUCTION

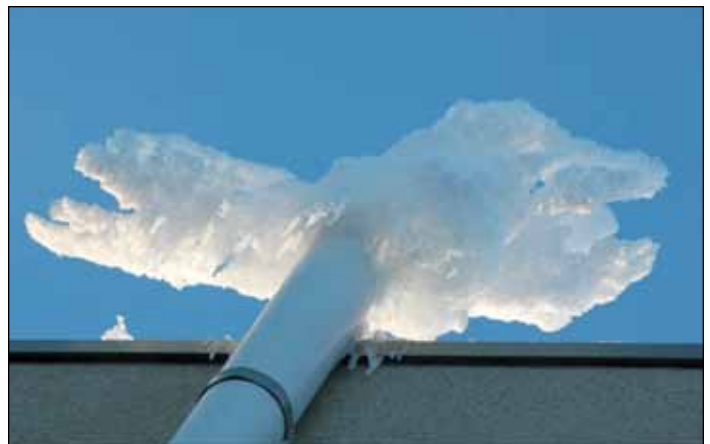
Figure 1 Frost covered radon vent in Winnipeg

In contrast, since the mid-1980s radon mitigation has been a relatively common activity in the United States (US) that has been supported by research and programs from the government's Environmental Protection Agency (EPA) and others. As a result, radon mitigation in the US is undertaken following the methods, systems and designs prescribed in guidelines such as the American Society for Testing and Materials (ASTM) E2121-09 "Standard Practice for Installing Radon Mitigation Systems in Existing Low-Rise Residential Buildings". While most American installations use a fan and exhaust venting located outside the house envelope, there is a concern that the system could be susceptible to ice build up particularly in colder regions.
